## EFFECT OF PRE AND POST WELD HEAT TREATMENTS ON THE MICROSTRUCTURE AND MECHANICAL PROPERTIES OF FIBER OPTIC BEAM DELIVERY SYSTEM ASSISTED ROBOTIC Nd: YAG LASER WELDED Ti-6AI-4V ALLOY

In the present study, Ti6Al4V titanium alloy plates were joined using robotic laser welding method. Pre- and post-weld heat treatments were applied to laser welded joints. After welding stress relieving, solution heat treatment and ageing were also applied to preheated laser welded samples. Effects of heat treatment conditions on microstructural characteristics and mechanical properties of robotic laser welded joints were studied. Aged samples were found to be made of coarsened grains compared to microstructures of non-aged samples. There were increases in ductility and impact toughness of samples applied to ageing increased, while hardness and tensile strength of non-aged samples were higher. The highest value for tensile strength and for impact toughness in welded samples have been identified as 840 MPa and 27 J, respectively. Fractures in tensile test samples and base metal impact test samples took place in the form of ductile fracture, while laser welded impact test samples had fractures in the

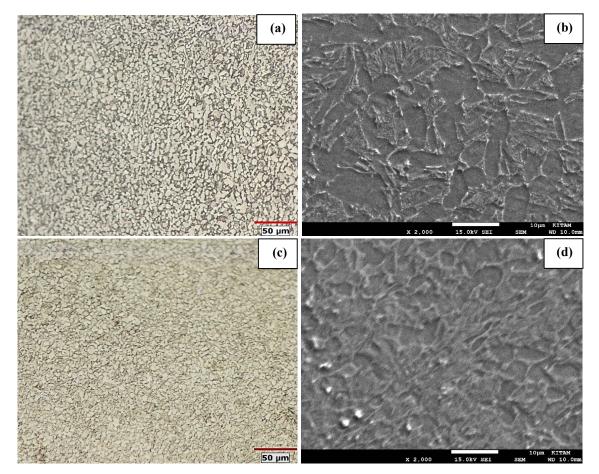
It was observed that microstructure of base metals (sample A and sample B) was made of coaxial  $\alpha$  grains and  $\beta$  grains in grain boundaries (Fig. 2a and 2c optical microscopy images, Figure 2b and 2d SEM images).

Fig. 2. Microstructure images of base metal, (a) and (b) Sample A, (c) and (d) Sample B

The microstructural change occurring after heat treatment is expected to slightly lower the tensile strength of laser welded joints and to increase the ductility in weld zone. Since the heat inputs of samples joined with different welding speed and of aged samples (samples A1 and A2) were similar, microstructures of weld metal and HAZ were similar too. (Fig. 2a-d). A similar situation was evident in non-aged samples (samples B1 and

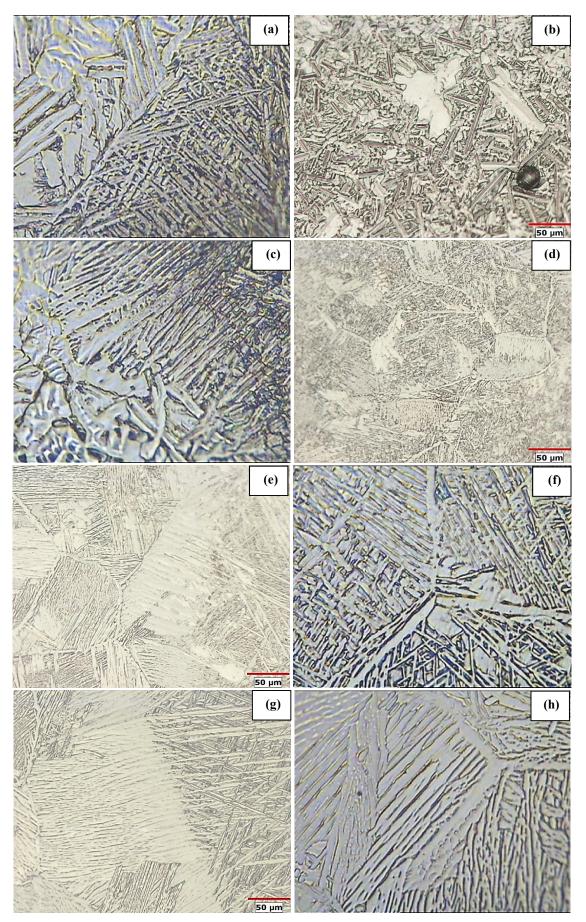
Fig. 3. Microstructure images of welded joint, (a) HAZ at 1000× magnification and (b) weld metal of sample A1 at 200× magnification, (c) HAZ at 1000× magnification and (d) weld metal of A2 at 200× magnification, (e) HAZ at 200× magnification and (f) weld metal of sample B1 at 1000× magnification, (g) HAZ at 200× magnification and (h) weld metal of sample B2 at 1000× magnification

B2) in Figure 2e-h. A narrow HAZ formation was observed in all of laser welded joints. Clear grain coarsening, lamellar  $\alpha + \beta$ phase structure and basket-weave Widmanstatten grain structure formation in grain boundaries of  $\alpha + \beta$  phase in weld metal and HAZ were observed in microstructure of laser welded samples, especially in weld metal, with or without ageing heat treatment as a result of high temperature and prolonged treatment. As expected, grain coarsening took place more efficiently in aged samples A1 and A2 (Fig. 3). Since temperature of heat treatment was lower than  $\beta$  transus temperature, a complete transformation of  $\alpha$  boundary structure to  $\beta$  phase was not expected. The grain boundary  $\alpha$  phase may not fully been transformed into  $\beta$ , but it will be incorporated with the  $\alpha$  platelets in the transformed  $\beta$ during the cooling and aging that follow [8,25]. It was observed that transformed  $\beta$  volume ratio increased in aged samples. Porosity formations were observed in welding seam (Fig. 3b and Fig. 4a and 4b). Porosity formation is a common occurrence in laser welded titanium alloys. Gas porosities generally form due to the fact that hydrogen in welding pool cannot be removed efficiently especially during solidification of welding seam [26]. Porosity formation is expected to lower mechanical strenght of welded joints.

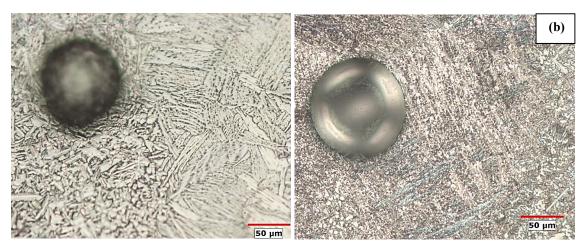
Fig. 4. Porosity formation in the weld metal of A1 and B1 samples

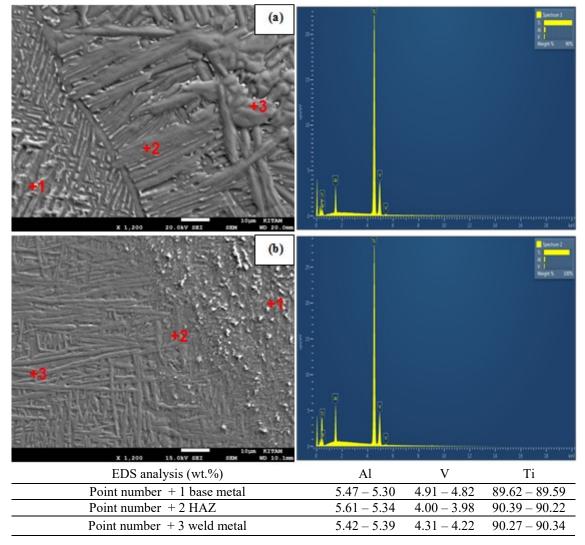
EDS analysis performed for all heat treatment conditions and welding parameters (Fig. 5) revealed that major element losses were not observed in base metal, HAZ and weld metal. These findings indicated that heat input or heat treatments did not exert a negative effect on laser welded joints concerning alloying elements evaporation. Greater element losses were identified in aged samples compared to the ones in non-aged samples.

Fig. 5. EDS analysis of base metal, HAZ and weld metal, respectively (a) Sample A1, (b) Sample B1 (weight%)

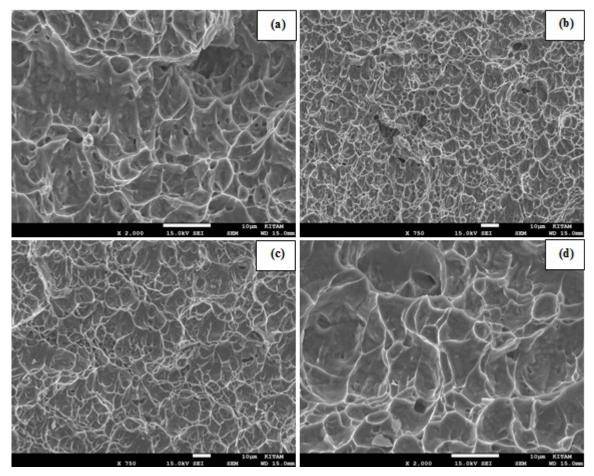
SEM images of fracture surfaces of base metals (samples A and B) and laser welded samples after tensile test (Fig. 6) clearly revealed that fractures occurred in the form of ductile fracture which is typical to heat treated titanium alloy as evident by dimples. No inclusion formation was observed in fracture surface images of laser welded joints.

Fig. 6. Fracture surface images of base metal and laser welded samples after the tensile test, (a) Sample A, (b) Sample B, (c) Sample A1, (d) Sample B1

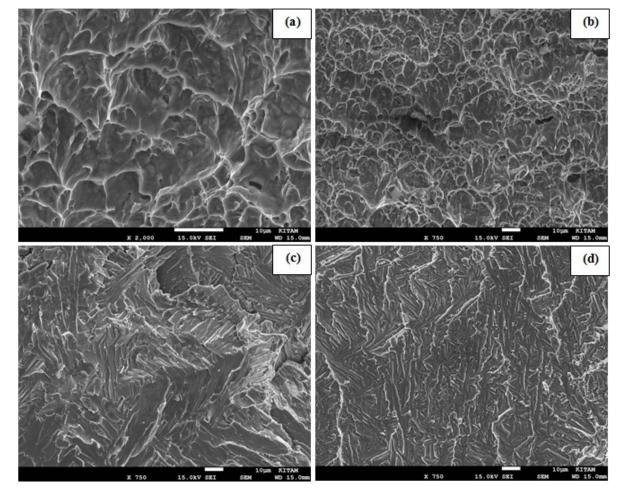
Fracture surfaces of base metal and welded samples after impact test were studied using SEM (Fig. 8). The base metal sample A and sample B were broken in ductile fracture mode, while A1 and B1 samples had fractures in the mode of intergranular fractures with either a quasi-cleavage type or tear ridges.

Fig. 8. Fracture surface images of base metal and laser welded samples after The Charpy V-notch impact test, (a) Sample A, (b) Sample B, (c) Sample A1, (d) Sample B1

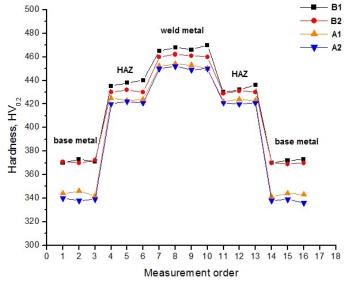
Laser welding ensures higher hardness levels in welded joints due to its higher power intensity, lower heat input and realization of rapid solidification compared to traditional welding methods. In terms of average hardness of heat treated samples joined using different welding speed and laser power i.e., using different heat input (Fig. 9), hardness of weld metal and HAZ was higher than that of base metal.

It was found out that the maximum hardness was in weld metal. The main reason for weld metal to be harder than HAZ

Fig. 9. Microhardness distributions in the welded joints

ductile than  $\alpha$  phase. It has been reported that through post-weld heat treatments, a hardness increase could be experienced especially in weld metal as a result of decreasing  $\beta$  phase structure [8]. Hardness of laser welded samples subjected to ageing heat treatment (samples A1 and A2) were somewhat lower than that of non-aged samples (samples B1 and B2). A loss in hardness could arise through transformation of martensite phase to  $\alpha$ ,  $\beta$ phase structure and coarsening of grain structure, and it has been specifically mentioned that increasing temperatures in post-weld heat treatments would lower hardness [25]. Higher hardness of HAZ and weld metal compared to base metal is expected to produce welded joints more strength than base metal. Hardness results are expected to be associated with tensile strength results. Nevertheless, such was not the case with the present study due to the presence of porosities or microcrack formations in weld metal and HAZ.

- was that this region was made of finer structured grains. Hardness increases are expected in HAZ and weld metal compared to base metal after post-weld heat treatments because of transformation of martensite to  $\alpha + \beta$  phase structure and transformation of phase platelet from retained  $\beta$  phase [8].  $\beta$  phase is softer and more
- 1. A clear grain coarsening in weld metal and HAZ, basketweave Widmanstatten grain structure formations in lamellar  $\alpha + \beta$  phase structure and grain boundaries of  $\alpha$  phase took place especially in weld metal microstructure of laser weld-
